# Manhole Inspection Summary

# Manhole # S09YY1005MH

Insp Date: **7/14/06 2:51 PM**

**Location** Address: **5801 BERKELEY AVE**

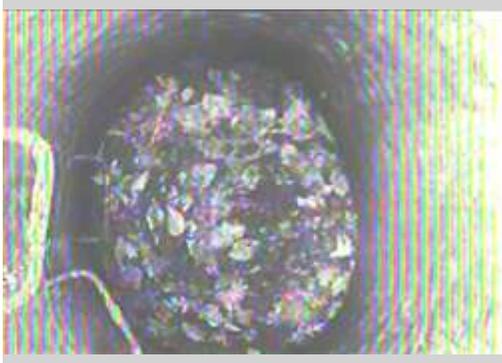
Top View

Corroded and missing steps. Channel debris.

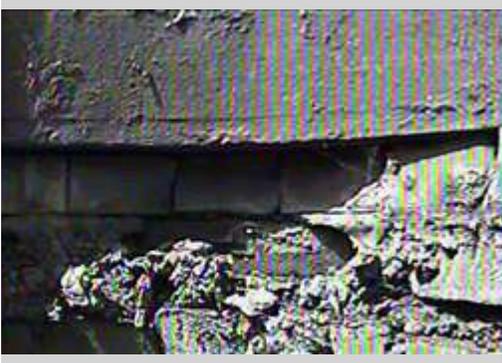
Defect

Frame leaks. Adjustment deterioration, loose brick, and infiltration.

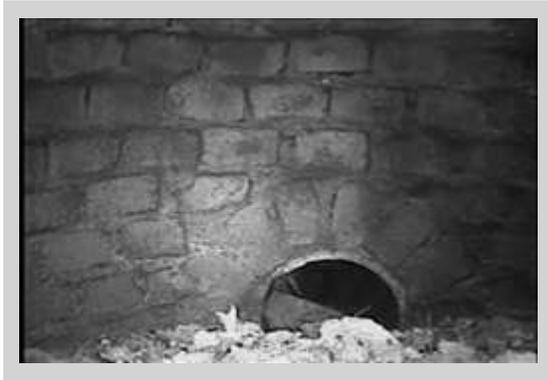
**8 in. Circular Gravity Sewer**  
**Pipe Out @ 12 O'Clock**

Barrel infiltration.
